APPENDIX 3

AN INVESTIGATION INTO ANCIENT MORTARS

MARIE KLINGSPOR ROTSTEIN & DANIEL KWIATKOWSKI

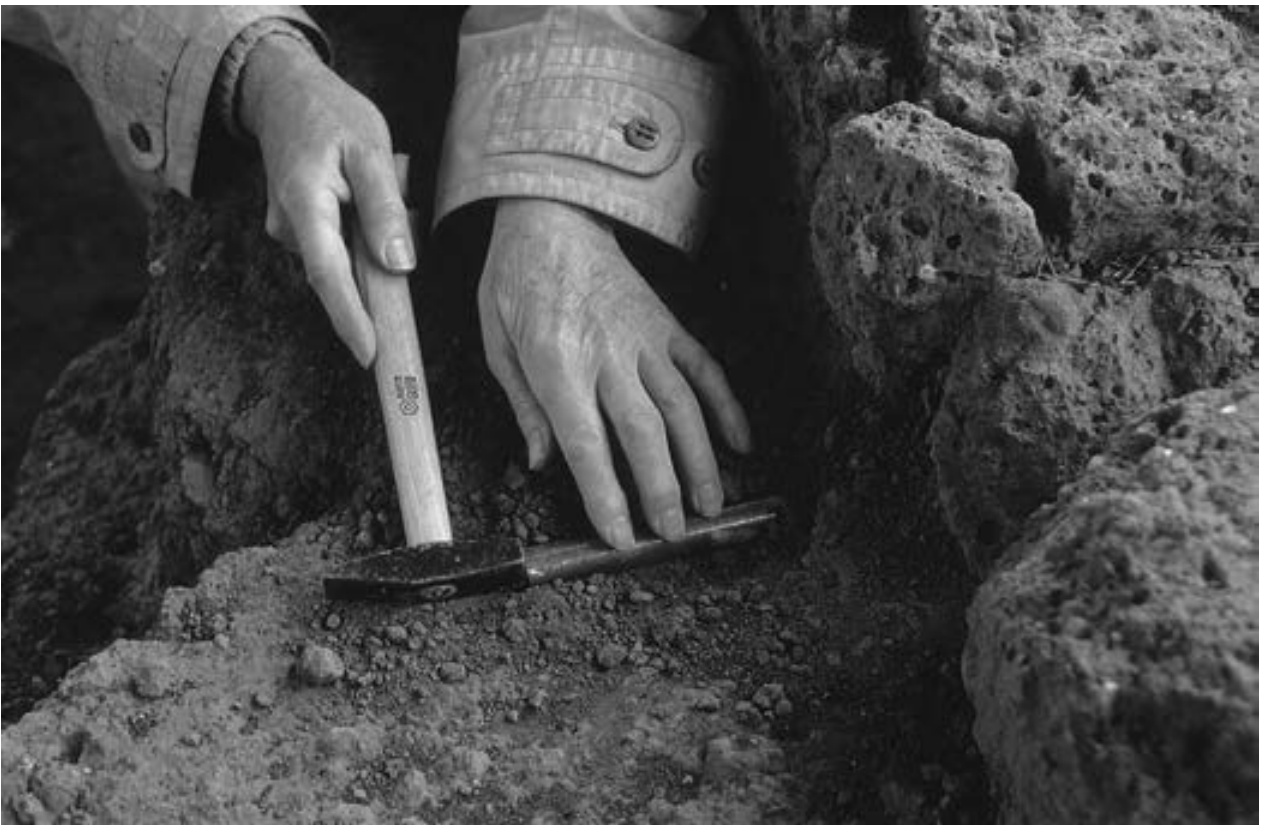
Fig. 140. Yard Ad, wall A1. Some of the samples were taken from the untouched filling material of the saved soil of the baulk, using tubes. Left of this sample is the spot where a tufa sample 0, block was taken. Photograph by M. Klingspor Rotstein.

Sample no. 0 is a largish rock fragment, somewhat compounded; can be crumbled with ease.

A slight porosity is evident in the sample. The colour of the rock: greyish rusty with a very slightly blotchy appearance, derived from the presence of integral elements of a differing colour. Some of these were white crumbling clumps, with a circumference

of up to 0.5 cm, and some dark grey, up to 2 cm in circumference. These components are volcanic lava with a fibrous structure. In addition, there are black and dark brown lava fragments, but the latter are less hard and disintegrate easily under pressure. Also seen under a microscope are black grainy shapes, usually flattened or elongated. Thin scale-like shapes (most likely mica) can be split from these. Colourless, flat, angular, glass like, transparent minerals are also sporadically in evidence.

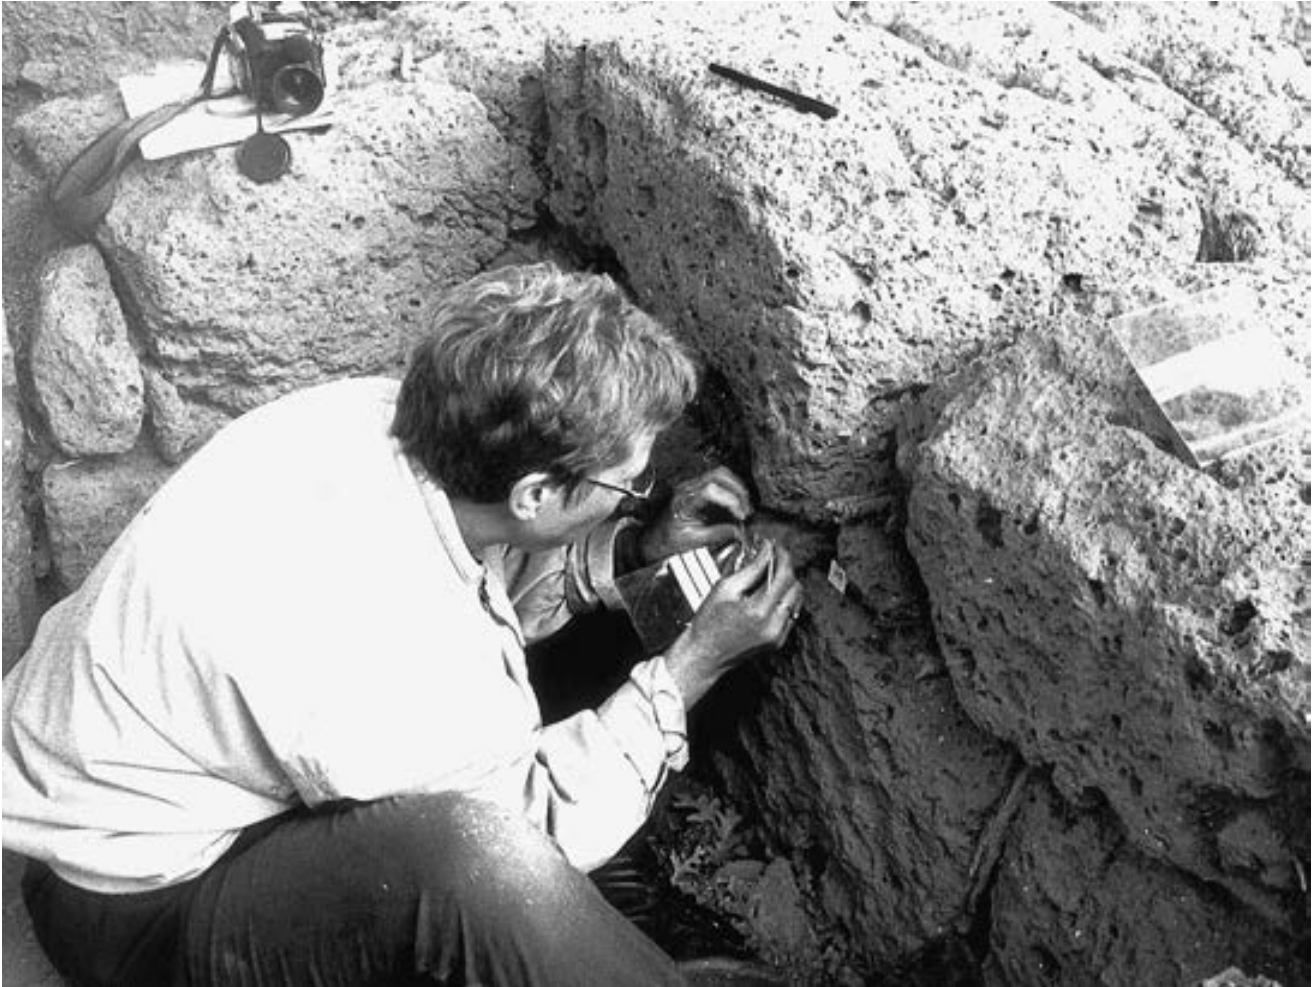
Fig. 141. It was quite difficult to extract a big enough piece to be suitable for analysis, from the frail material in the joints. Photograph by B. Blomé.

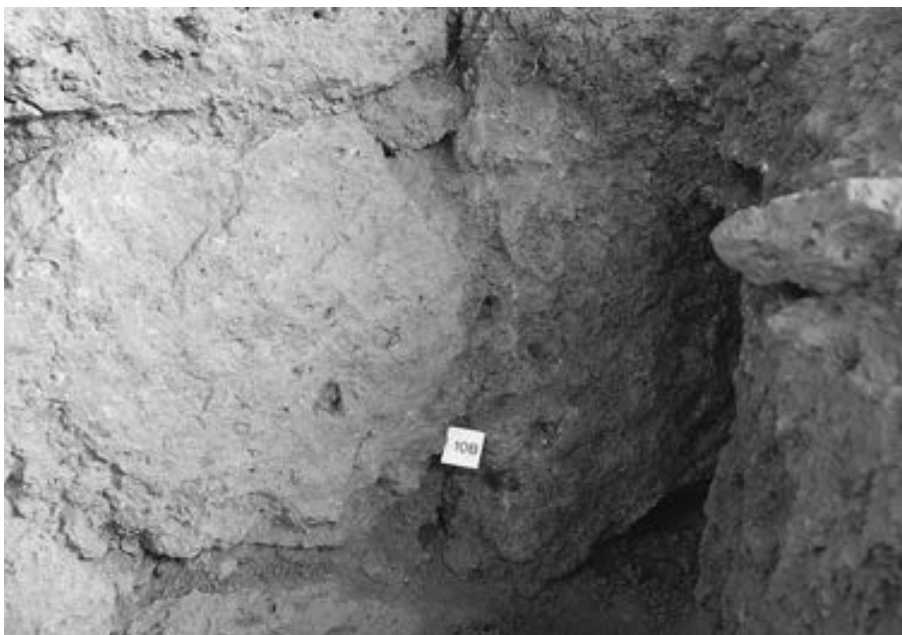
Fig. 144. House B, saved soil B1. Sample 10B was taken from the joint behind the saved untouched soil of the baulk. Photograph by M. Klingspor Rotstein.

The samples are loosely bound and fragment into clumps of differing sizes and have a greyish rusty colour. Sometimes there are white clumps crumbling into powder, as well as white, more compounded and crusty shapes or mineral clusters in the basic paste. Sporadically, grains of detritic quartz (crushed), small scale-like mica shapes, and flat, transparent, glass-like shapes, that are not quartz crystals, are evident. There are fragments of volcanic lava in the various samples.

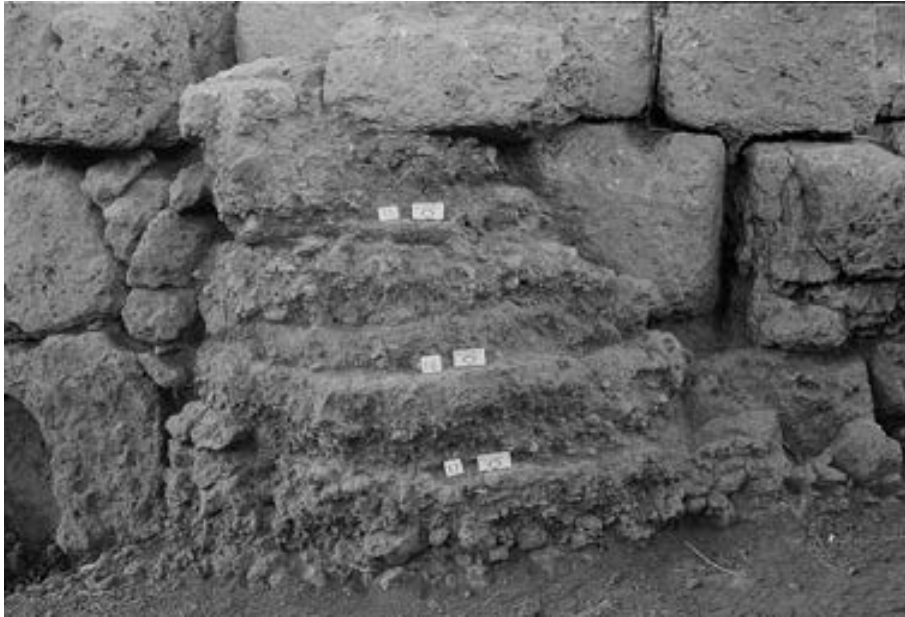
Fig. 147. Area Bc, saved soil in a baulk by Drain L. Samples CN16 and CN17 are described in the text. Photograph by M. Klingspor Rotstein.

Sample no. CN16 (Fig. 147) has a light brown colour, occasionally somewhat rusty. It is generally heterogeneous and varied, with black lithological elements (lava). This sample is relatively frail. The other properties of this sample are analogical with earlier floor samples.

Sample no. CN17 (Fig. 147) has a greyish brown colour with a clear porosity, but is, despite this, quite compounded. The contents correspond with those of earlier samples. It differs only by a smaller amount of glass-like uncoloured minerals, and a larger amount of white, compounded minerals (crust-like).
