## APPENDIX 3

# AN INVESTIGATION INTO ANCIENT MORTARS

MARIE KLINGSPOR ROTSTEIN & DANIEL KWIATKOWSKI

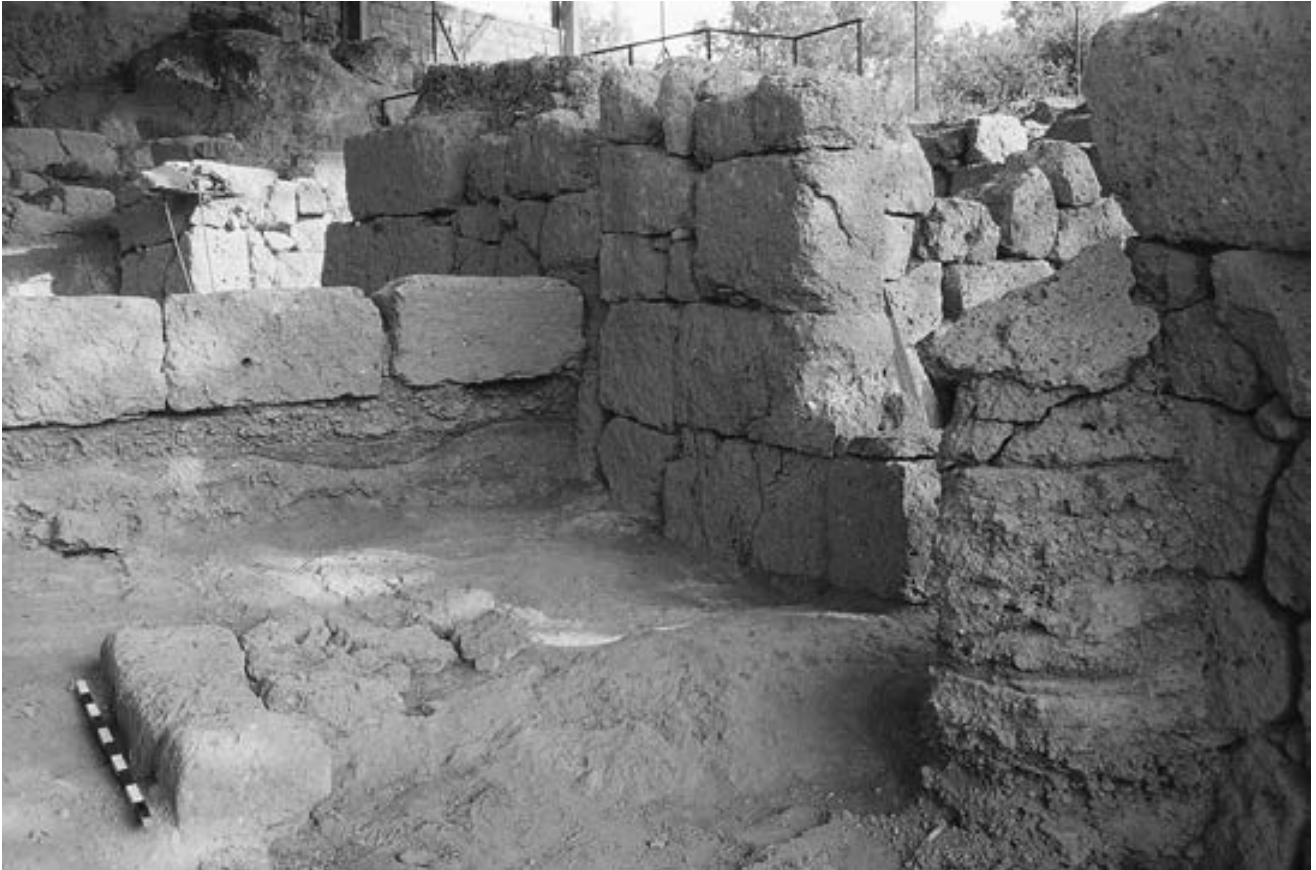
Fig. 137. Area Bc between walls C8 and B3, with saved untouched soil in the baulk. Photograph by M. Klingspor Rotstein.

The walls had been thoroughly cleaned during excavation. By foresight, soil baulks had been left intact in certain places, close to some of the walls, thus consisting of untouched material (*Fig. 137*). Samples were taken from this soil by inserting steel rods, which then came to contain material from outside the walls and from fillings between blocks (*Fig. 138*). In addition, samples were taken from flooring material and layers (*Fig. 139*), and from a section which presumably could have been used as a hearth. The authors have later, together with the Copernicus University in Poland, undertaken petrographical (lithological) analyses, supported by X-ray diffraction.

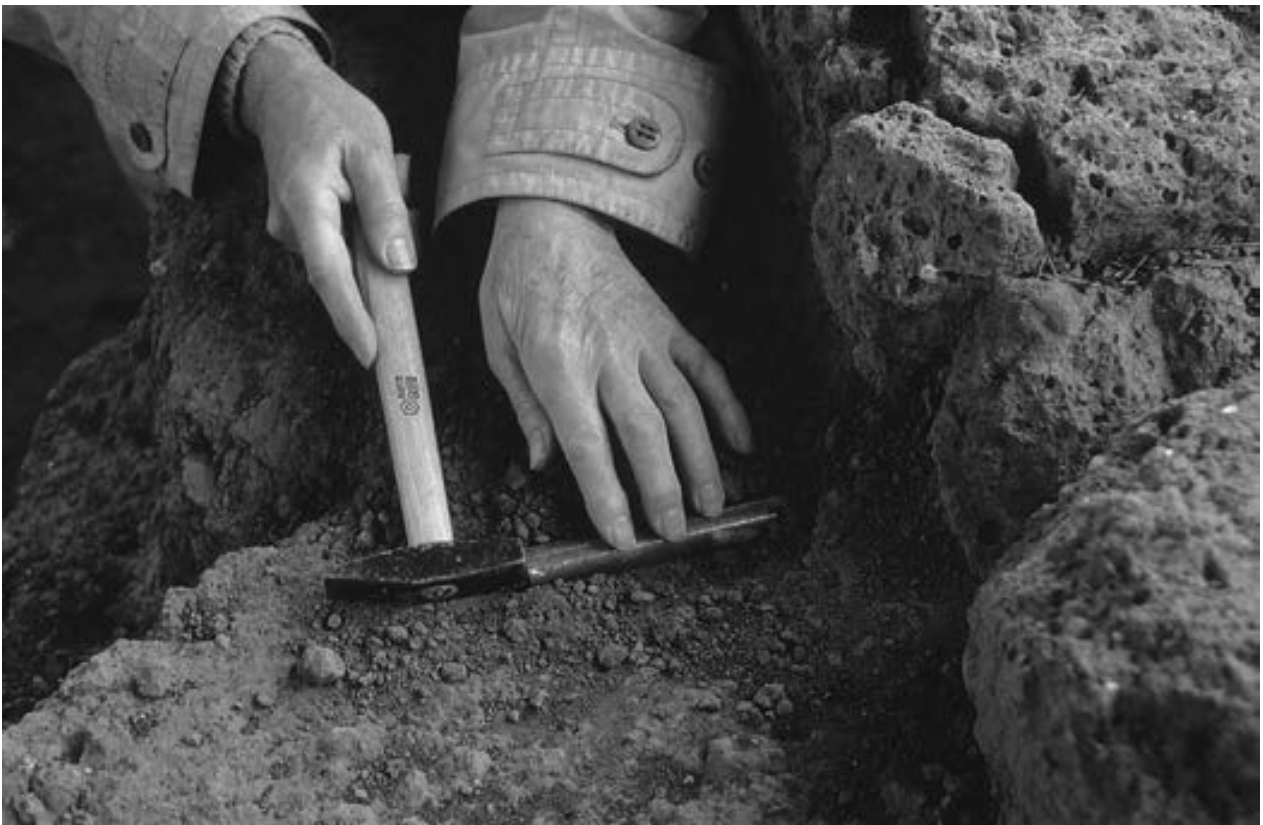
Fig. 140. Yard Ad, wall A1. Some of the samples were taken from the untouched filling material of the saved soil of the baulk, using tubes. Left of this sample is the spot where a tufa sample 0, block was taken. Photograph by M. Klingspor Rotstein.

Sample no. 0 is a largish rock fragment, somewhat compounded; can be crumbled with ease.

A slight porosity is evident in the sample. The colour of the rock: greyish rusty with a very slightly blotchy appearance, derived from the presence of integral elements of a differing colour. Some of these were white crumbling clumps, with a circumference

of up to 0.5 cm, and some dark grey, up to 2 cm in circumference. These components are volcanic lava with a fibrous structure. In addition, there are black and dark brown lava fragments, but the latter are less hard and disintegrate easily under pressure. Also seen under a microscope are black grainy shapes, usually flattened or elongated. Thin scale-like shapes (most likely mica) can be split from these. Colourless, flat, angular, glass like, transparent minerals are also sporadically in evidence.

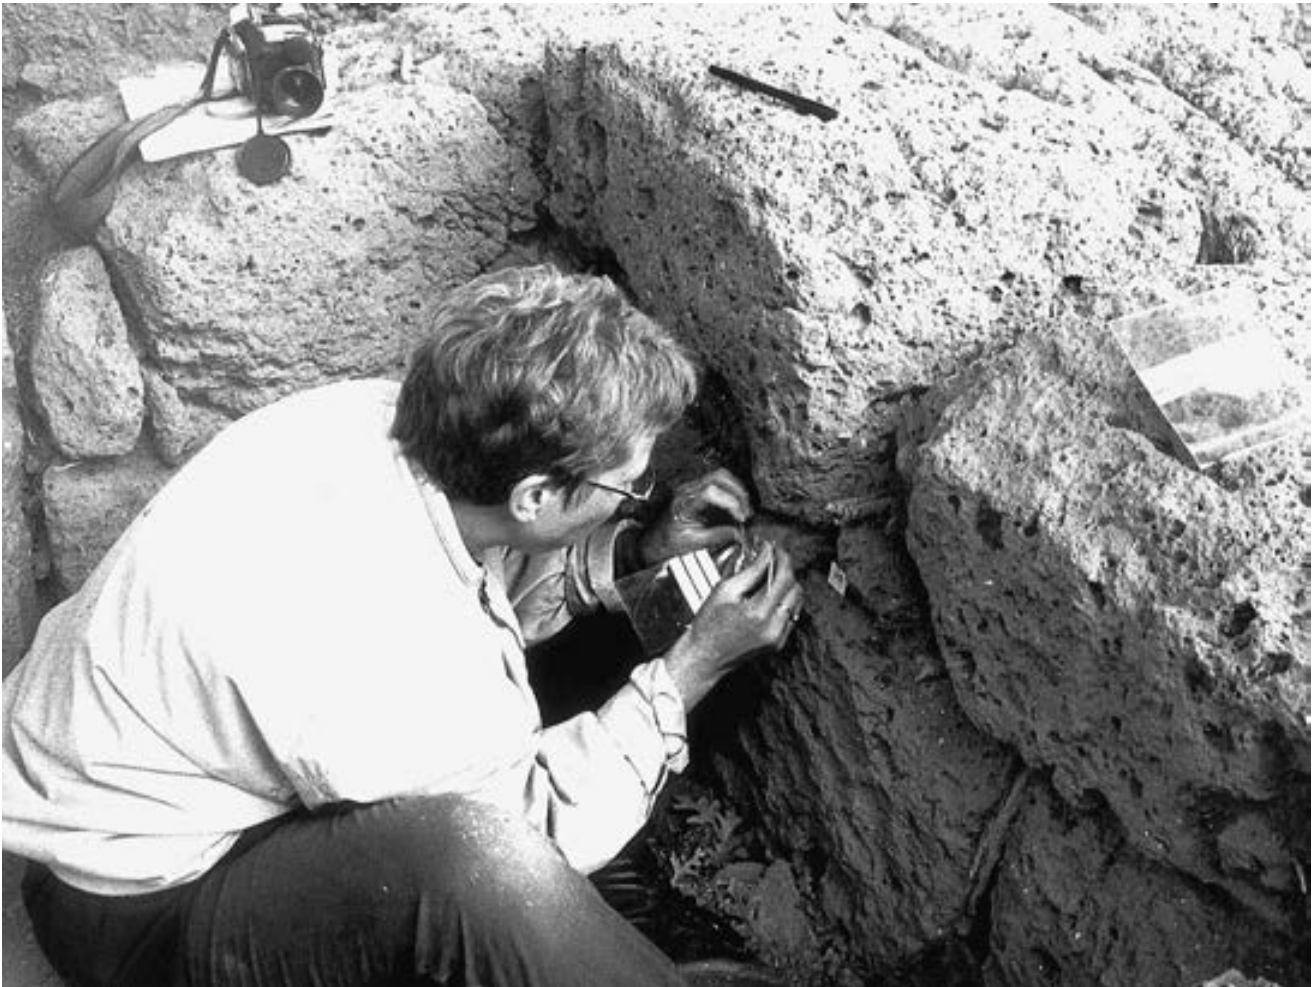
Fig. 141. It was quite difficult to extract a big enough piece to be suitable for analysis, from the frail material in the joints. Photograph by B. Blomé.

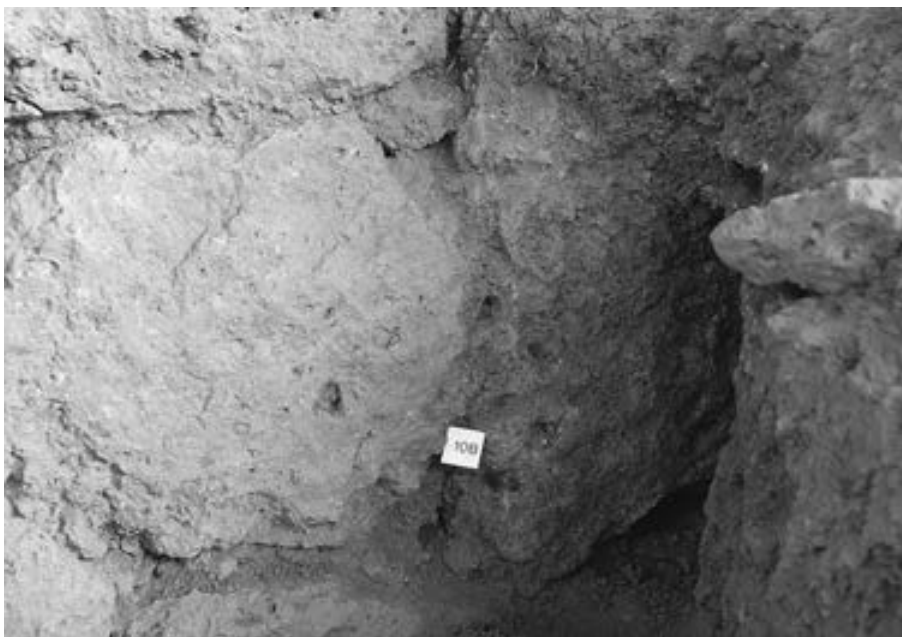
Fig. 144. House B, saved soil B1. Sample 10B was taken from the joint behind the saved untouched soil of the baulk. Photograph by M. Klingspor Rotstein.

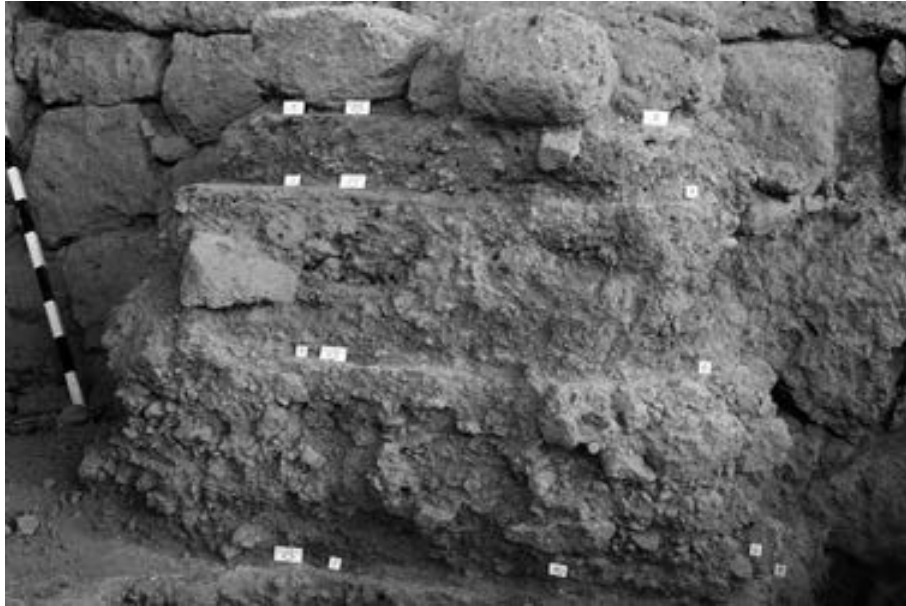
Fig. 145. House B, wall B1, saved soil from the baulk. Samples floor CN1 and CN3 are described in the text. Sample 0A (zero A) soil was also taken from this piece of soil as comparison. Sample 10B was likewise taken from this place. Photograph by M. Klingspor Rotstein.

Sample no. 0A is from the saved, untouched soil baulk adjoining the walls. It is a porous formation of fragments of vulcanite with grains of dark glass, for example obsidian; fragments of rock with white mineral substance; non-crystalline silicon dioxide (perhaps including chabazite); with a presence of detritic quartz (perhaps not in large quantities but clearly present); also detritic or uncrystallized feldspar—orthoclase and decomposed biotite.

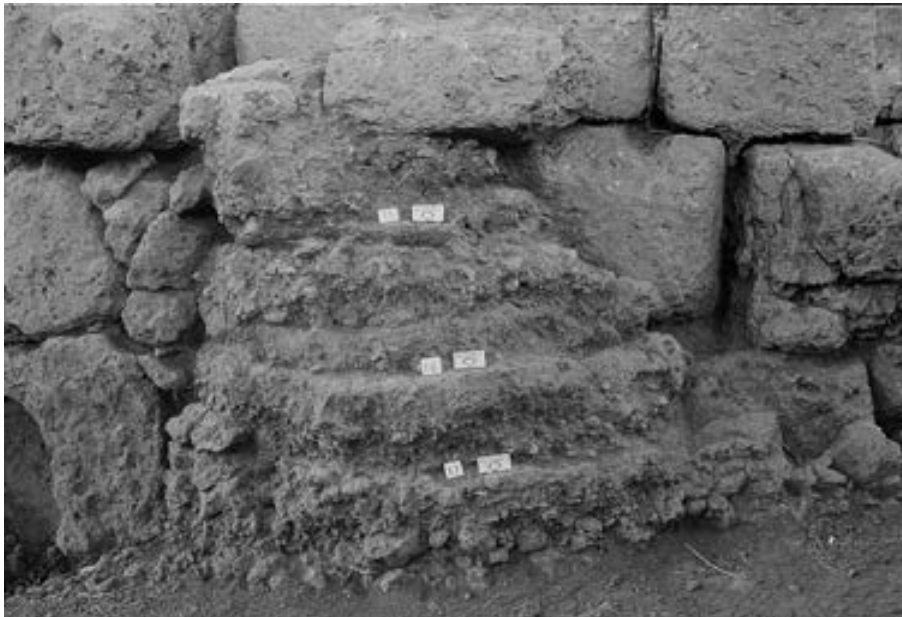
Fig. 147. Area Bc, saved soil in a baulk by Drain L. Samples CN16 and CN17 are described in the text. Photograph by M. Klingspor Rotstein.

Sample no. CN16 (Fig. 147) has a light brown colour, occasionally somewhat rusty. It is generally heterogeneous and varied, with black lithological elements (lava). This sample is relatively frail. The other properties of this sample are analogical with earlier floor samples.

Sample no. CN17 (*Fig. 147*) has a greyish brown colour with a clear porosity, but is, despite this, quite compounded. The contents correspond with those of earlier samples. It differs only by a smaller amount of glass-like uncoloured minerals, and a larger amount of white, compounded minerals (crust-like).
