CHAPTER SIX  
THE GREAT FILL PROJECT  
(late 7th century BC)

Towards the late 7th century BC, the north-west part of the Borgo NW area was drastically changed. The 20 m long, east–west slope, with a sharp drop of some 6–7 m, was now reshaped. This required four major activities and which will be discussed in more detail in this chapter: (a) in the upper, eastern part of the slope it was necessary to remove much rock in order to obtain a suitable workshop area; (b) in the lower and sloping, western part it was necessary to create a sturdy terrace wall/fortification Ma-Me and a major fill; (c) the construction of a substantial drain carrying away the rain water from the higher, eastern area of the Borgo; and (d) the substantial constructions D3/D4 and D5/D6 with a terracing function under House D. This was a demanding project and was probably beyond what a few local people were able to handle. It is likely that the entire community was active in changing the Borgo NW area to a workshop area for metallurgy.

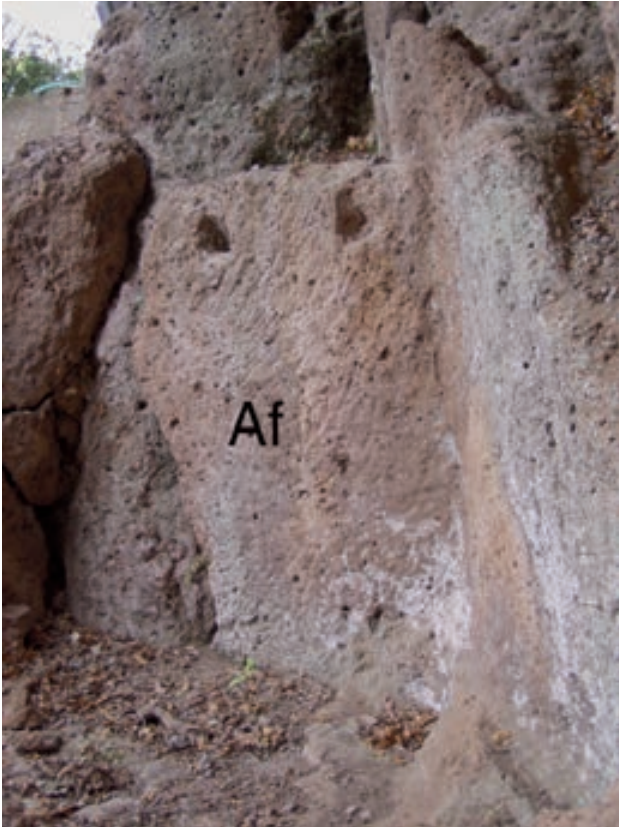
Fig. 56. The shaped rock TRe and niche Af. Photograph by J. Sigurdsson.

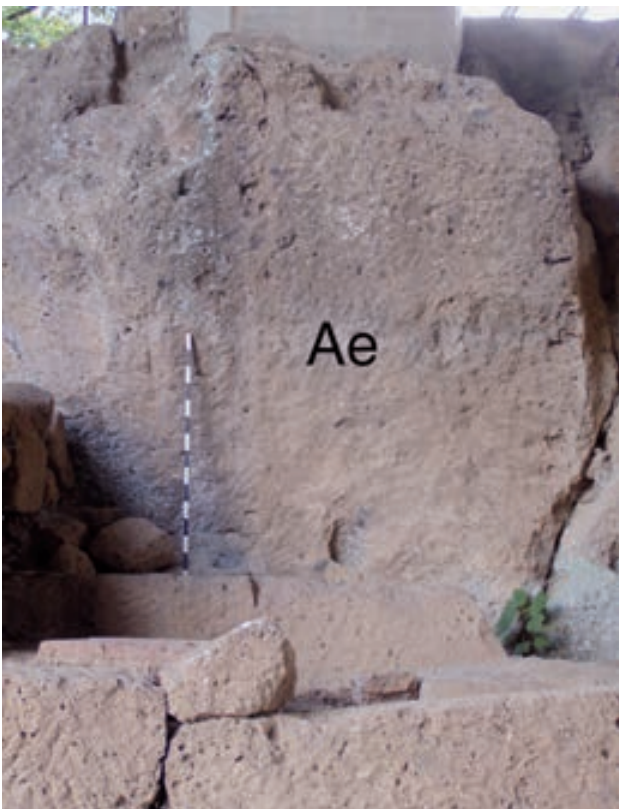
Fig. 57. The shaped rock TRe and cistern Ae. Photograph by J. Sigurdsson.

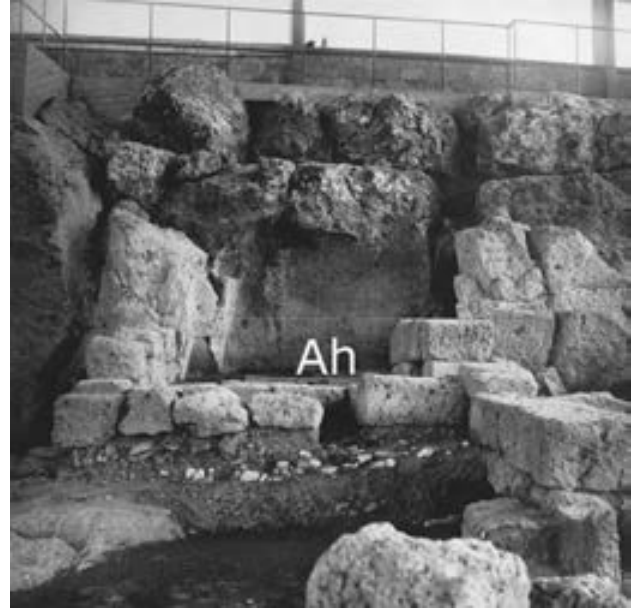
Fig. 58. The shaped rock TRe and niche Ah. In the background the modern fence above the rock. Photograph by B. Blomé.

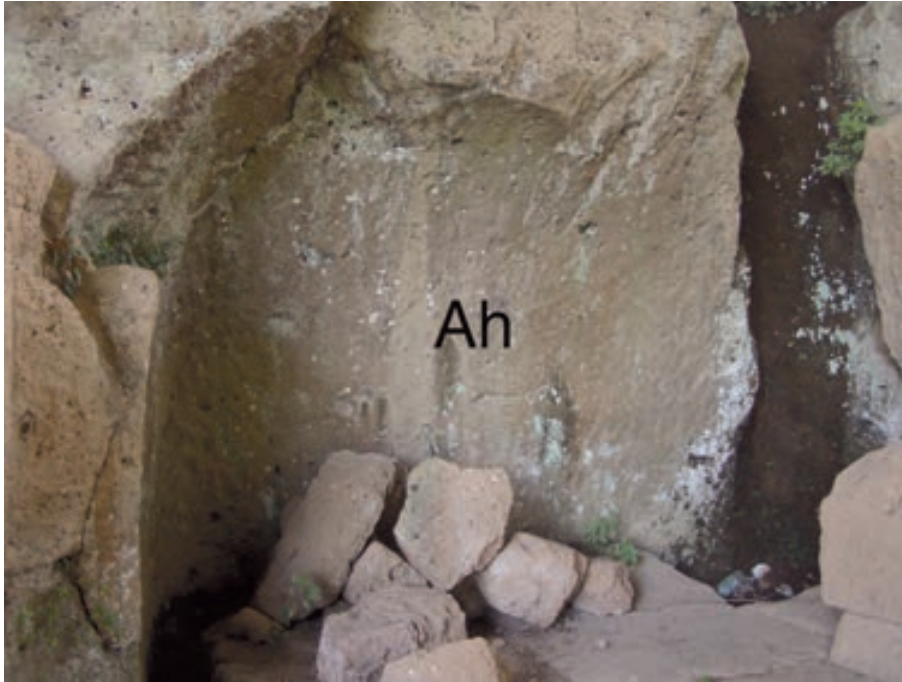
Fig. 59. The shaped rock TRe and niche Ah. Photograph by J. Sigurdsson.

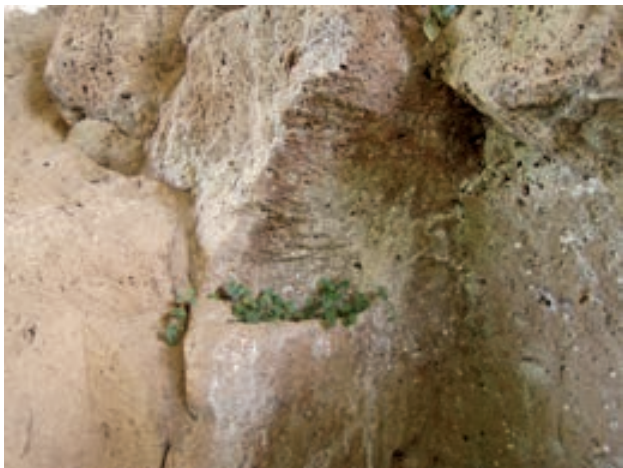
Fig. 61. Marks of the pick-axe on niche Ah. Photograph by J. Sigurdsson.

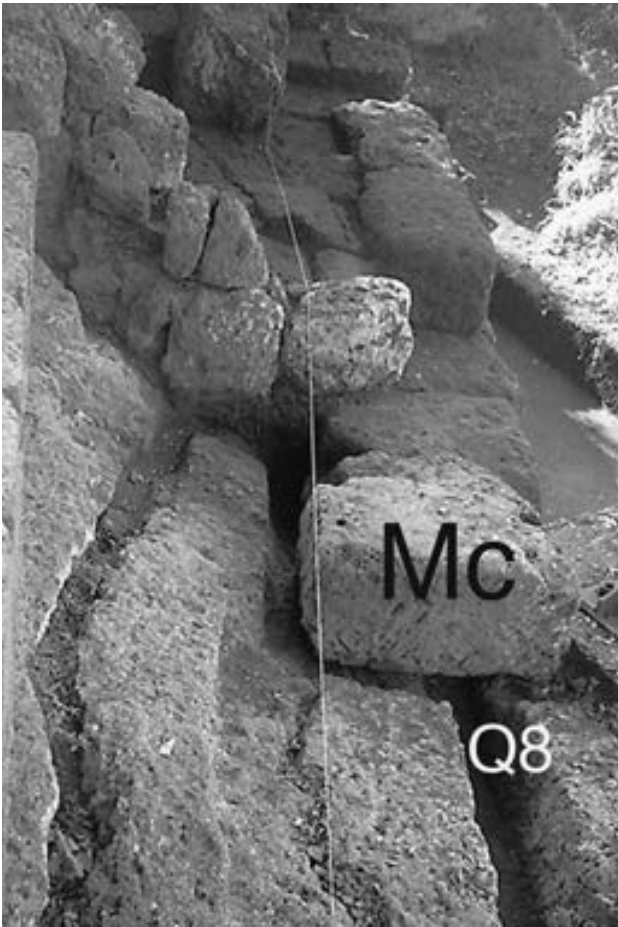
Fig. 65. Terrace wall/fortification Mc and palisade canal Q8. Photograph by B. Blomé.

race wall/fortification along the western slope (Ma-Mb-Mc, *Figs. 64–65*) and then disappear in the unexcavated areas towards the south (Md-Me), in the direction of the Acropolis (retraced further south in the excavations of 1999).<sup>76</sup>

through and behind the construction and has caused the fissure of some of the Mc blocks.<sup>90</sup> Underneath the Mc blocks runs the deep-cut palisade canal Q8. On a big ledge in the rock were laid the impressive first courses of wall Mc, the lowest course consisting of huge headers and the second of stretchers. The stretcher course has a series of headers behind the stretchers so as to reach a full depth of c. 1.60–1.70 m. There are seven huge headers preserved of course I, and these present a somewhat jagged front.<sup>91</sup> Their dimensions are: a uniform height of 0.45 m and a depth of 0.90 m, while the length varies between 0.45–0.60 m. Course II consists of only two huge stretchers (1)  $0.91 \times 0.45 \times 0.57$  m and (2)  $0.97 \times 0.45 \times 0.56$  m, with four headers laid behind (1)  $0.53 \times ? \times 1$  m; (2)  $0.46 \times ? \times 1.10$  m; (3)  $0.56 \times ? \times 1.10$  m; and (4)  $0.56 \times ? \times 1.10$  m. Only two blocks are preserved from course III, and they are not *in situ*.

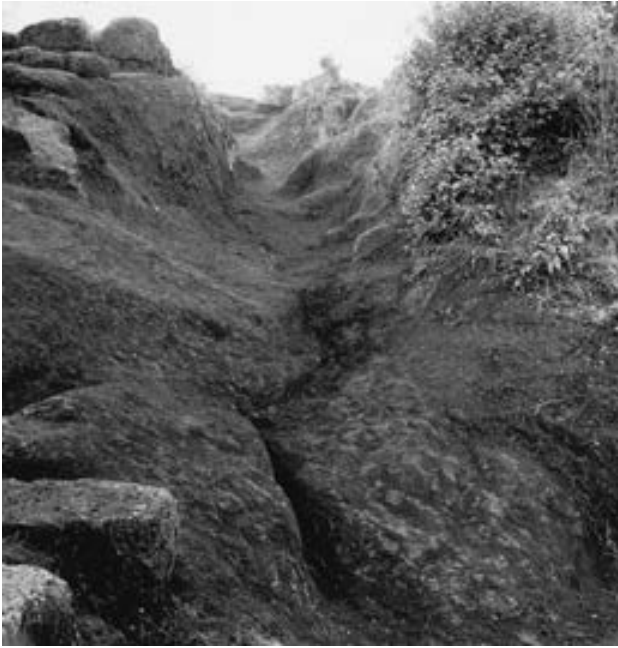
Fig. 67. Passage Nc. Photograph by B. Blomé.

Nb, Na and Ai, into the eastern rock-cut Af and Ac. From the area Nb a path, probably, leads through Nc (Fig. 67) up to the six steps (Fig. 68) leading to the southern, higher part of Borgo and to the Acropolis. No doubt, a gate was probably located in the western area. However, a section of the ancient remains has been destroyed in this area, between TRw/Md/Q9 and lower Md.

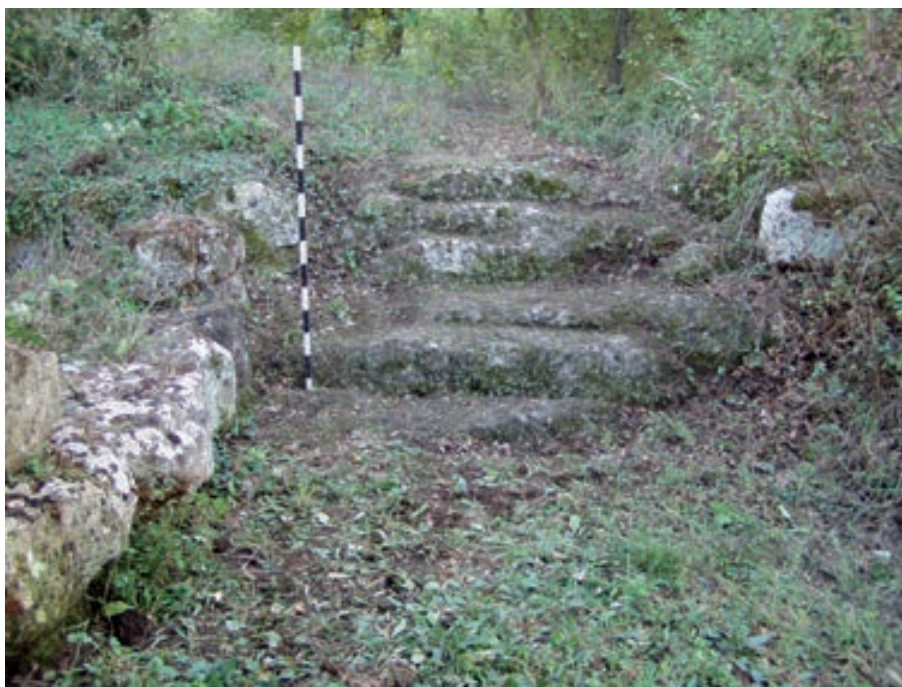
Fig. 68. Steps in the bedrock at Q15. Photograph by J. Sigurdsson.

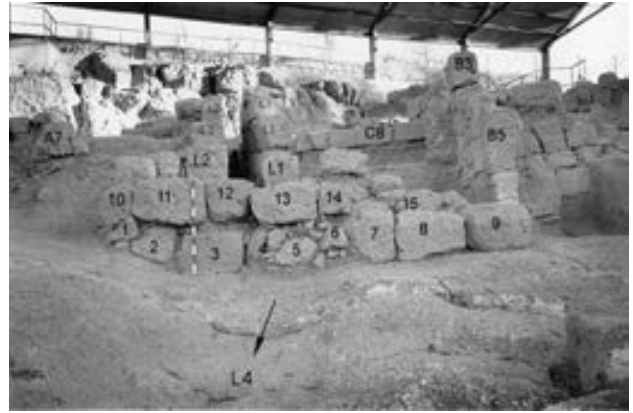
Fig. 70. Foundation N1 and Drain L consisting of the two substantial walls L1 and L2. Photograph by B. Blomé.

The front of N1 consists of the two somewhat irregular courses I and II. The majority of the blocks of course I (numbers 1–3 and 7–9) rest firmly on the tufa rock. The strong character of course I was initially interrupted in the middle, approximately beneath Drain L's outlet, by an opening of c. 1.10 m. Somewhat later, the smaller blocks, nos. 4–6, were laid in a mixture of earth, tufa stones and tile fragments. In front of this section, the tufa rock sloping towards the west is heavily eroded, no doubt caused

by running water. Course II consists of mostly big blocks, nos. 10–14, lying in some earth on top of course I. Course II extends backwards toward the Drain L outlet with blocks nos. 15–19. Further back there is another, higher “course”, partly standing on earth.

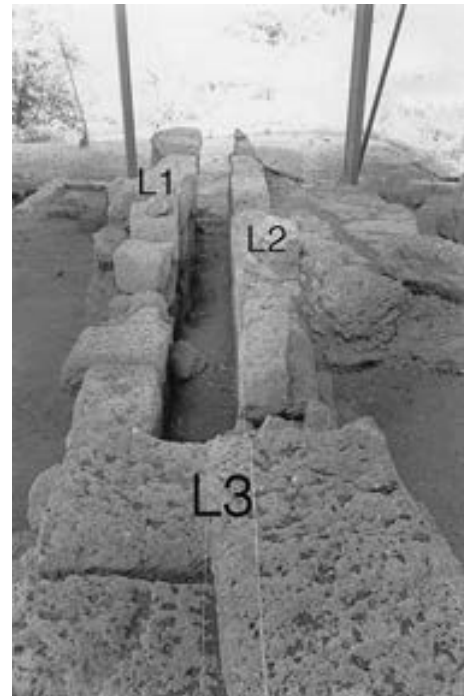
Fig. 71. Drain L towards the west. Photograph by B. Blomé.

The long Drain L with its two side walls L1 and L2 (Figs. 71–72), 11 and 13 m long, abuts wall N1 which is built on the tufa bedrock. N1 is a rough but powerful construction (c. 4.5 m long and 1.20–1.30 m deep), built with 25 very substantial tufa blocks. The heavy wall construction N1 had the special function of retaining the fills of courtyards Ad and Be, and, above all, to support the two walls L1 and L2 of Drain L, and also being a foundation for the outlet of Drain L.<sup>77</sup> Like the nearby wall section Mb/Mc, foundation N1 is one of the earliest construc-

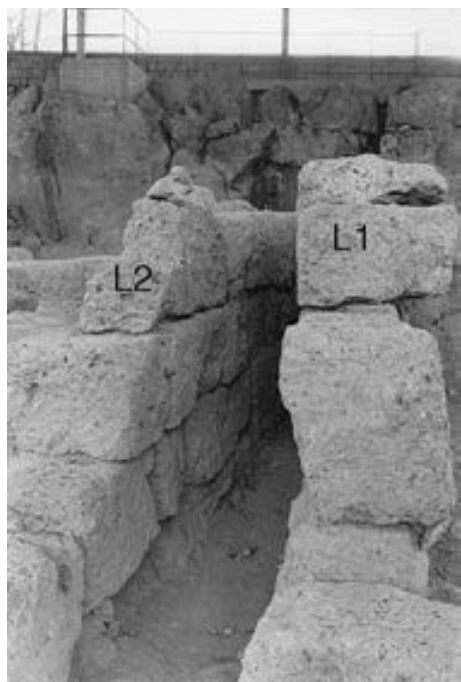
Fig. 72. Drain L towards the east. Photograph by B. Blomé.

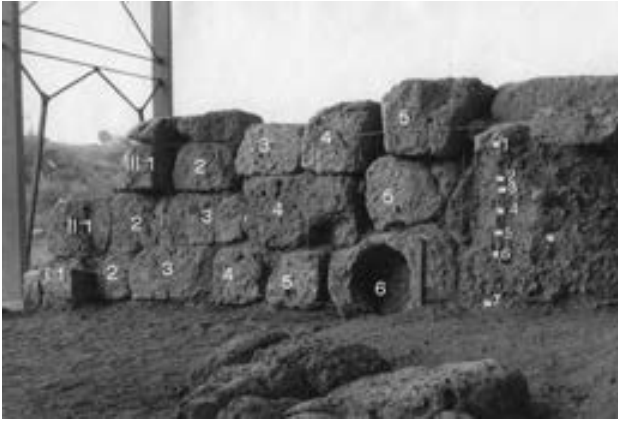
Fig. 75. Wall L1 from the south. Photograph by B. Blomé.

Wall L1a/b is not one of which the Etruscan stonemasons could feel very proud. It is a crude piece of masonry, built in four rather irregular courses, I–IV, of which only I (20 blocks) and II (4+10 blocks) are relatively well preserved. Considerable care was taken to ensure the stability of L1 but little to give it unity and coherence.<sup>94</sup> The brute albeit sturdy character of this high Drain-wall L1a/b with its reused blocks and uneven façade tends to show that its southern front was not intended to be visible. Its height of 1.60–1.70 m confirms that it did also have the function of a retaining wall for the fills, necessary in the Bc-area, as is clear from the accumulation and the sequences of (two or three) floor levels still visible on the preserved stratigraphic baulks.

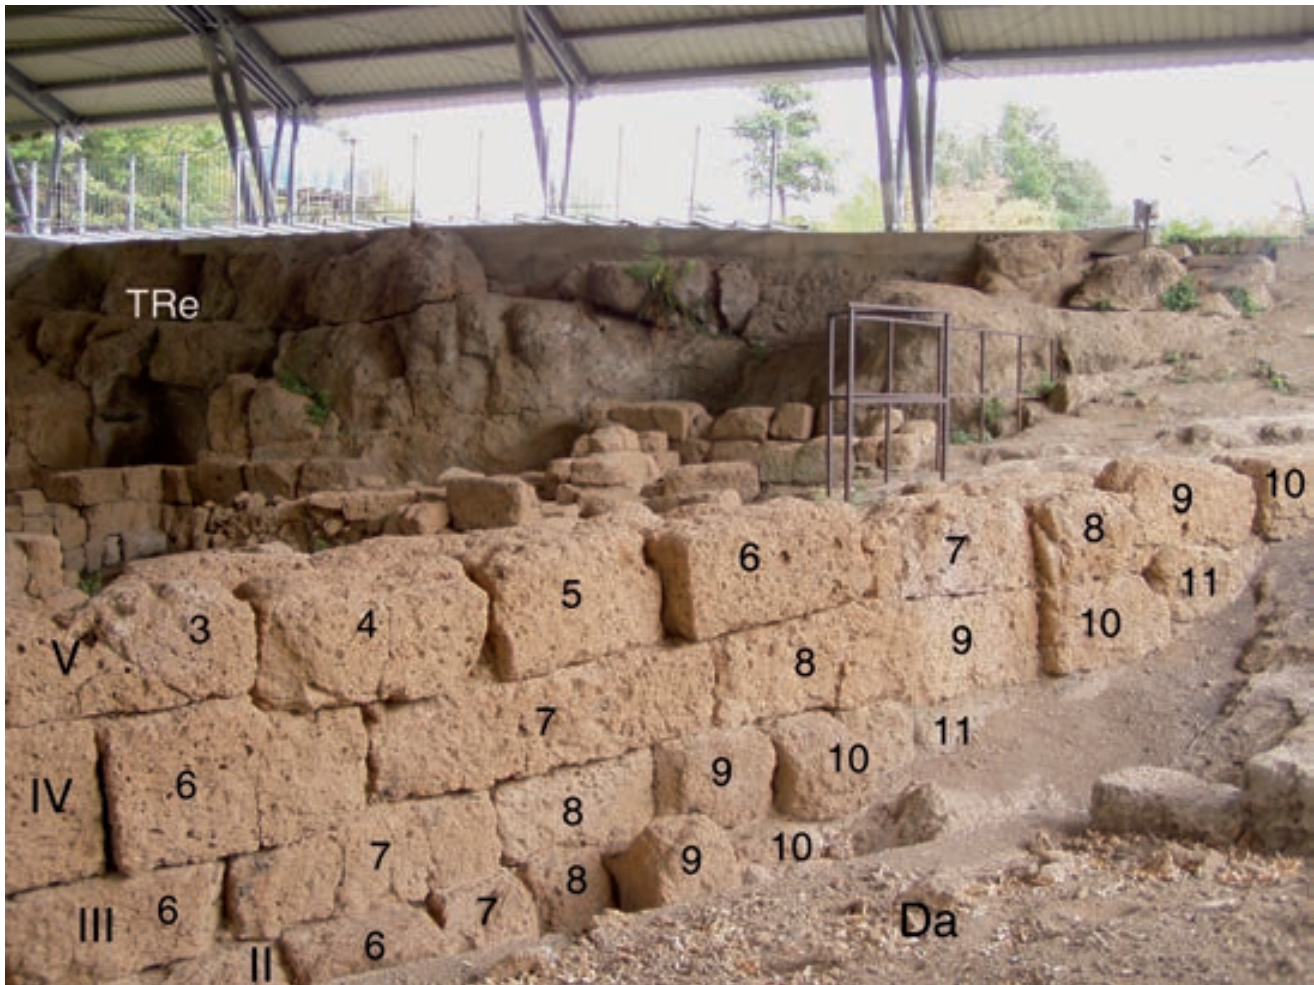
Fig. 79. Wall D3 from south-west. Photograph by J. Sigurdsson.

The strong terrace wall D3/D4 is quite impressive (Pl. 39). It runs along the slope for 15.10 m in an east–west direction and, at its western end, bends towards south into wall D4.<sup>79</sup> D3's northern façade which faces Lane K is only partly visible due to later constructions in Lane K and wall K2 in Period 3. However, the south façade of D3 is fully visible, exhibiting the care devoted to its strong construction. Wall D3 had to adapt, along its east–western length, to a slow, irregular drop in level of about 3 m and also to handle differences in the south–north direction.
